World Trade Center Post-Disaster Reconnaissance and Perishable Structural Engineering Data Collection

Field Investigation and Analyses of the Collapse of the World Trade Center

Abolhassan Astaneh-Asl

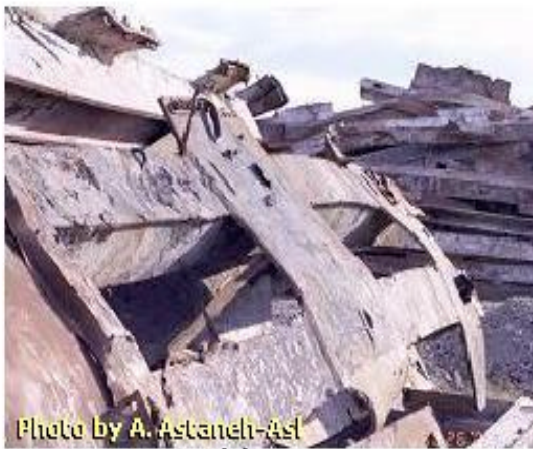
Figure 11 shows typical views of various components of the World Trade Center Towers after collapse. Figures 11(a) shows a view of one of the pre-fabricated units of the exterior tube. This unit appeared to be bent in a way that it may have been buckled while under the load instead of being bent due to drop from the height. The surface of this piece also appeared to clearly indicate exposure to intense and uniform fire throughout the clear length of column. In addition, there was no visible dent or damage that would indicate the bending might have been the result of other members falling on this particular member. Considering all these issues, which could be established by close and careful examination of structural pieces, one could reasonably conclude that this particular piece may have been damaged while the structure was still standing. This distinction is very important since if further identification of the piece indicate that indeed this piece may have been in a location that could have been subjected to intense fire, then by testing this element many valuable pieces of data could be gathered. There were a number of other pieces such as these that the author was able to identify as possibly important pieces and keep for further investigation.

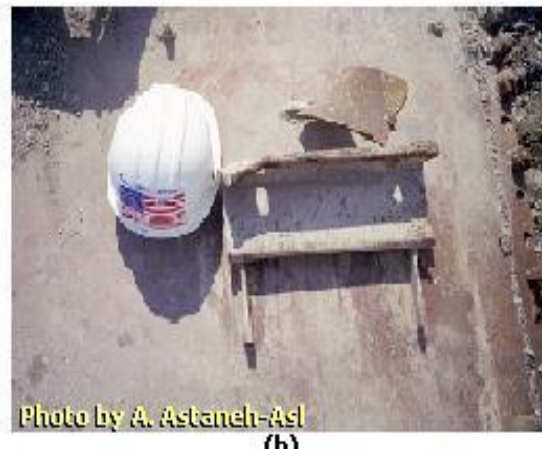
Figure 11(b) shows typical appearance of the seat angles supporting the floor double joists. The seat angle supports were on the every-other exterior columns. In general most seat angles that were inspected had their outstanding legs bent downward possibly due to the impact of collapsing floors from above. In some cases, the seat angles were gone due to failure of welds connecting them to the two outstanding plates behind them.

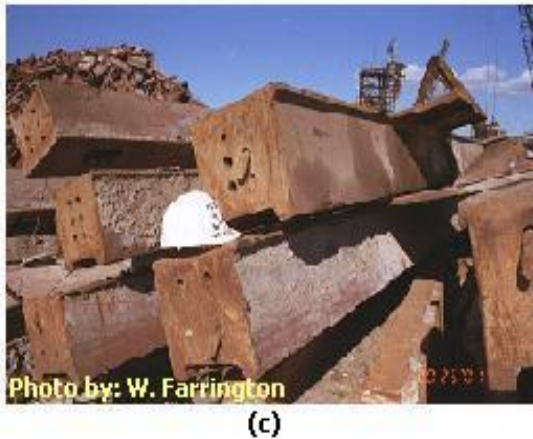
Figure 11(c) shows a view of the end plate splice connection of exterior box columns. In almost all cases that were inspected, The failure of splice was due to bolt failure in tension combined with bending.

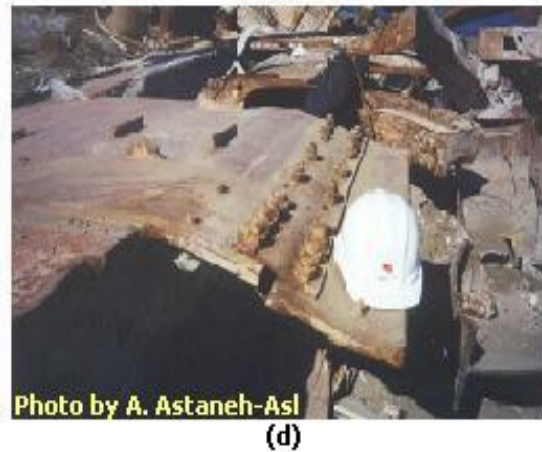
Figure 11(d) shows appearance of typical bolted double plate splices of the horizontal spandrel plates of the exterior tube.

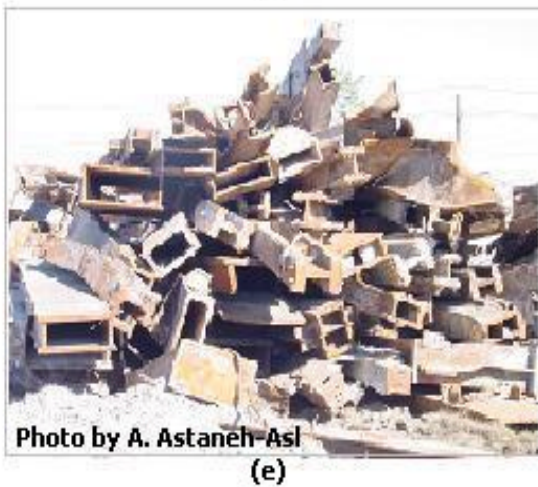
Figure 11(e) shows interior columns of the towers stacked on top of each other at recycling plant. Almost all interior column pieces that were inspected were intact and did not show failure of welds. As indicated earlier, these columns were gravity columns and their splices did not need to be designed for any amount of tension or bending. However, a

minimal splice was provided for these columns presumably for secondary forces and the forces during construction. Obviously, such minimal splices did not have a chance during the collapse stage to keep the columns together and had fractured. Observing the fact that the interior column splices were not needed and were so minimal, it is not clear if when the attacking Boeing 767 airplanes entered the towers any of the interior column were actually dislodged and eliminated or bent due to failure of their splices.

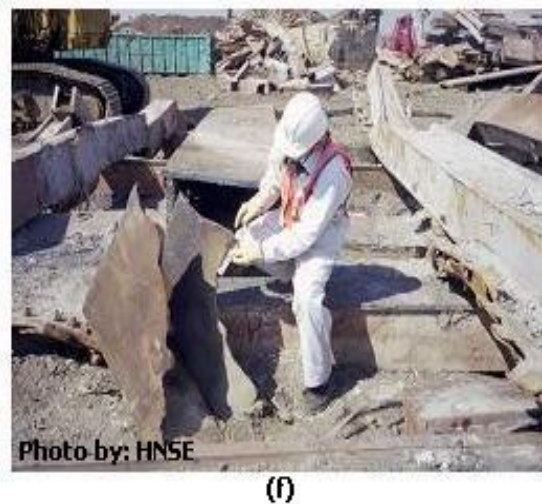
Figure 11(f) shows the author inspecting a piece of interior column that arose quite a lot of interest. The piece showed very clear signs of a large, round and fast moving object entering from the left side of the box and cutting a quarter of a circle hole in the column. It appeared at the time of its discovery among the steel at recycling plant that this column could be from the south tower. However, not having access to structural drawings at the time, it could not positively be identified as being at a floor level that could have been hit by the engine of the airliner entering the south tower. Further investigation of this piece can positively locate it and establish whether or not it is indeed hit by the airplane engine.
